Author Daishi Sakaguchi		
Title of thesis Potential for cascading wood from building		
Department Department of Forest Product Technology		
Professorship Fibre Product Technology	Code of professorship	Puu-28
Thesis supervisor Professor. Mark Hughes		
Thesis advisor(s) / Thesis examiner(s) Atsushi Takano, M.Sc (Tech) Larui Linkosalmi, M.Sc (Tech)		
Date 20.08.2014	Number of pages 85+10	Language English

There has been a growing interest in cascading materials recovered from buildings as the amount of construction and demolition waste (C&DW) has been increasing. In Finland, cascading wood from building can be one of the effective approaches considering that there are a lot of wooden buildings, which are now due for renovation or demolition. From this point, investigating the available amount, as well as the potential for cascading, is significant. However, the statistics available to discuss the potential are limited at the moment. Therefore, this study aimed to obtain the required data through a case study of a building demolition and to analyze the potential of cascading wood from the building.

The case study building was a wooden building (Kindergarten) in Porvoo. The possible am

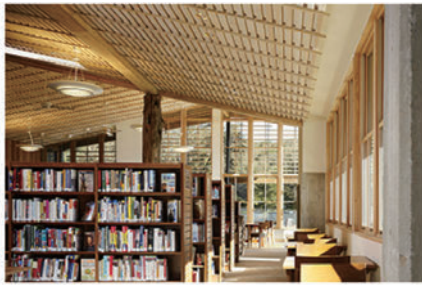
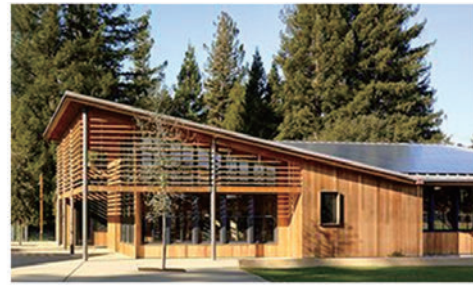
Figure 4a. and 4b. Examples of secondary use in building (adopted from *Design for reuse primer*, 2010, p.16,18)

In non-structural parts, special properties are not required. As for use in interior finishes, the visual properties of recovered wood (the color and atmosphere) are more important (Figure 4a). The visual properties are also important in the exterior uses shown in Figure 4b. For ceiling and floor paneling, the same things can be mentioned.

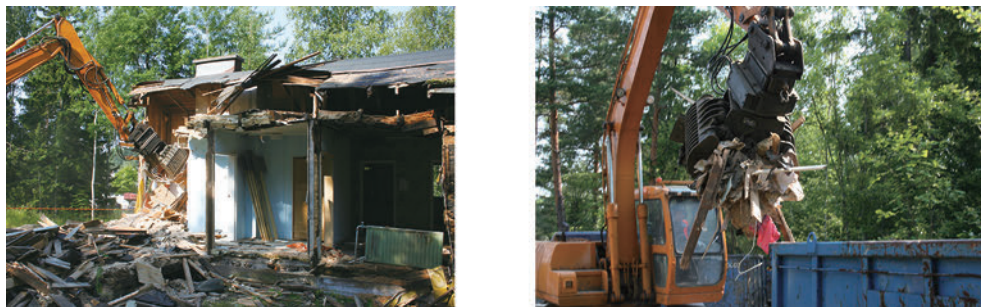
Figure 9a and 9b Basic demolition method in Finland

In Finland, the demolition method is mainly the grabbing and crushing. The method is decided by the operator of the machine. At first, some interior parts are demolished by hand. After that, each part of building is grabbed and crashed by machine (Figure 9a). Finally, the waste is separated and placed into each container (Figure 9b). The priority in demolition is on the efficiency and separation of each waste to minimize the processing cost.

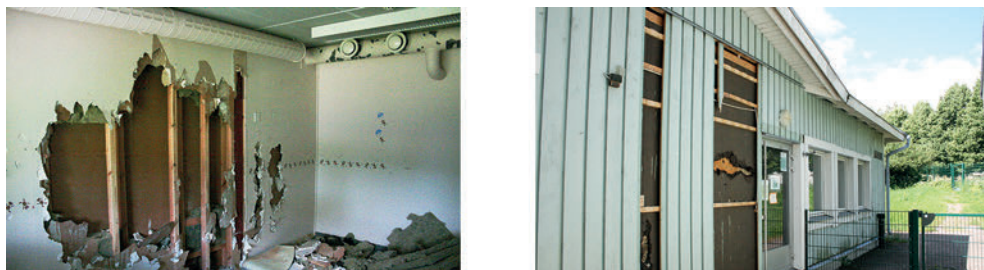
Figure 13. Details of internal and external walls

The structure of the case study building was checked on the site before the demolition started, since the detailed drawings for the building were not available. The inside of each element was individually opened to observe the members and to measure the dimension of each member (Figure 13). Through detailed observation, the required data were collected and the structure of each building is illustrated in Figure 14. The floor plan is also attached as Figure 15. Based on this data, the length of wood in each element were individually measured from the drawings and the total amount of wood was calculated.

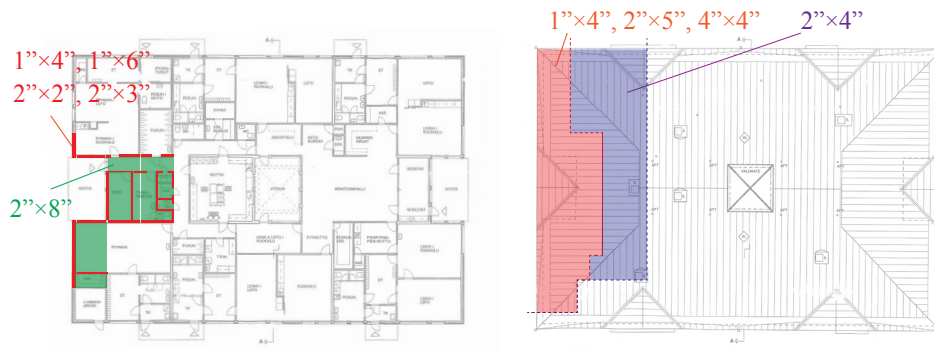
Figure 16. Demolished area in each element

Figure 16 shows the demolished area in the assessment and each recovered wood was sampled from these areas. 10 recovered pieces of woods for each cross-section were randomly and individually sampled.

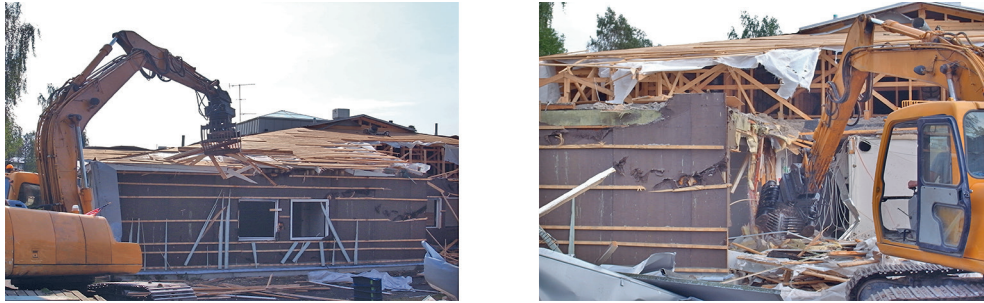
Figure 22. Demolition method for the case study building

The demolition method was a combination of grabbing and crushing as seen in the pre-observation (Figure 22). First, the exterior cladding was grabbed separately from the exterior wall and the material from the roof part was ripped off and separated into different waste categories. After that, the exterior wall, interior wall, floor, and ceiling were crushed or grabbed as an element.

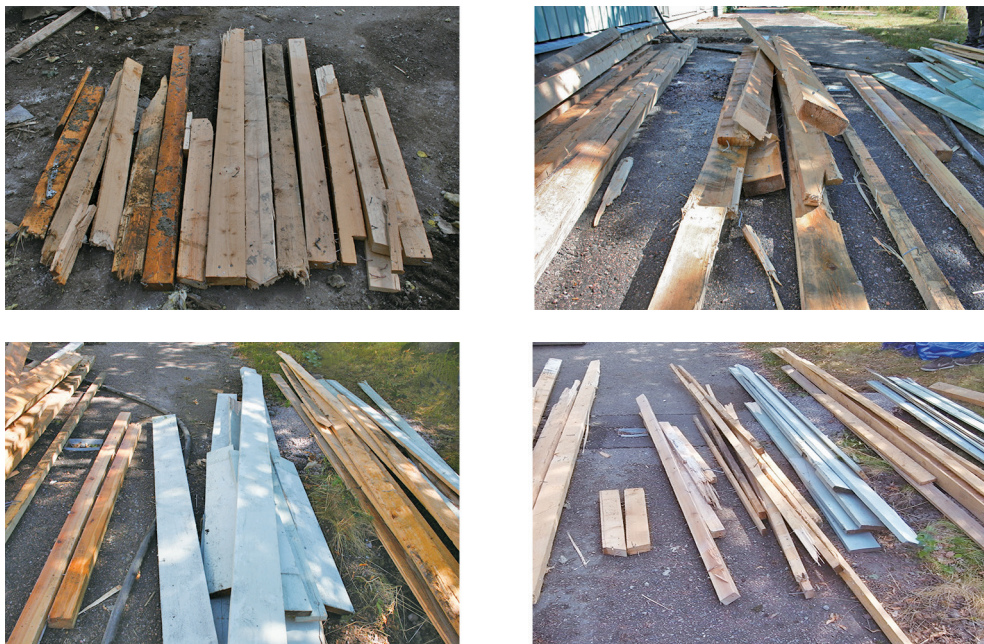
Figure 23. Condition of wood recovered from the building

Each recovered wood type was sampled from the piles according to the cross-section and the cleanliness, and the required information was measured. Examples of the recovered condition of each wood are shown in Figure 23.

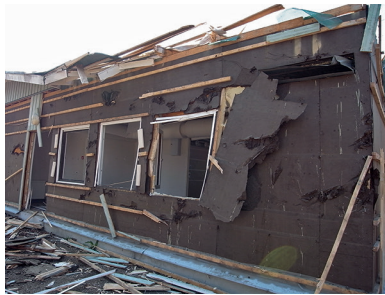
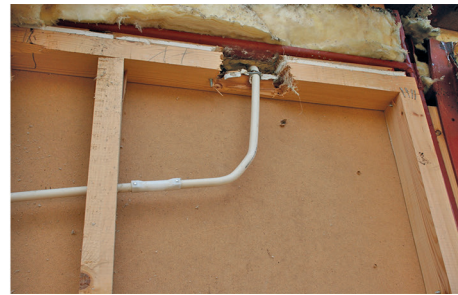
Figure 26a. and 26b. Same dimensional lumbers used in different element

In the pre-assessment, the amount of wood was calculated in each element such as exterior wall, interior wall, partition wall, floor, ceiling and roof. It was understood that some of the same dimension wood was used in different elements. For instance, the 2"×2" were used as a button in the exterior walls and ceilings. The 2"×3" were used as the studs in the exterior, interior and partition walls (Figures 26a and 26b). The 2"×8" was used for the joists in the floor and ceiling elements.

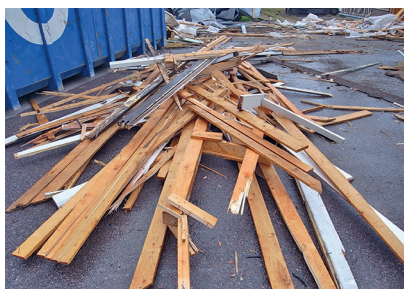
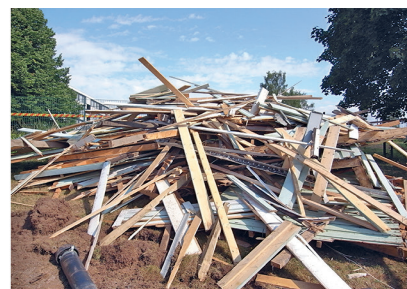
Figure 27a. and 27b. Different piles of recovered wood

One problem during the classification of recovered wood on site was that it was not possible to detect the original location of the same cross-section wood used in a different location. The reason is that all kinds of wood were mixed up in the pile. Views of the different piles are shown in Figures 27a and 27b.

To solve this problem, the location used for this analysis was determined as three different parts whose original location could be precisely found. The first and second parts were the independent parts consisting of the roof truss and cladding. The other is the unit part including the three different walls (except the exterior cladding), floor and ceiling elements in the building.

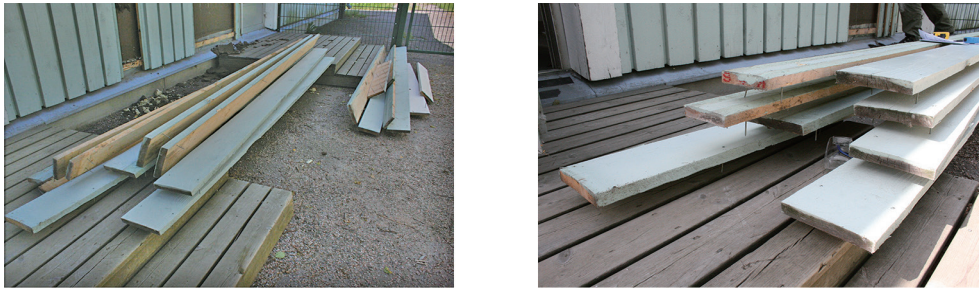
Figure 31a and 31b. Condition of exrerior cladding from the case study building

Considering the condition of recovered 1"×4" and 1"×6" with paint, they surely have potential for cascading provided the paint is not hazardous. In the case of the case study, the paint for the exterior cladding seemed a general paint and it was painted only on the surface as seen in Figures 31a and 31b even though the details of the paint should be confirmed by a future study.

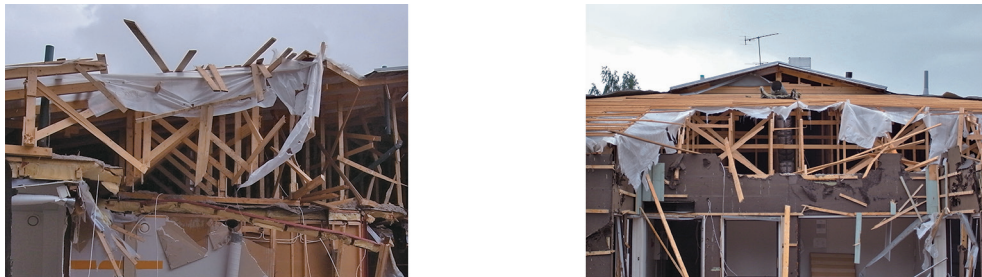
Figure 34. 1"×4" brace and furring strip in roof part

However, there is an issue with the 1"×4" used as a roof brace and furring strip (Figure 34). It was easily broken into smaller pieces from the grabbed part when it was roughly grabbed out of the roof pillar. This is mainly because both edges of the brace were attached to the pillar with nails and it caused breakage in the grabbed part.

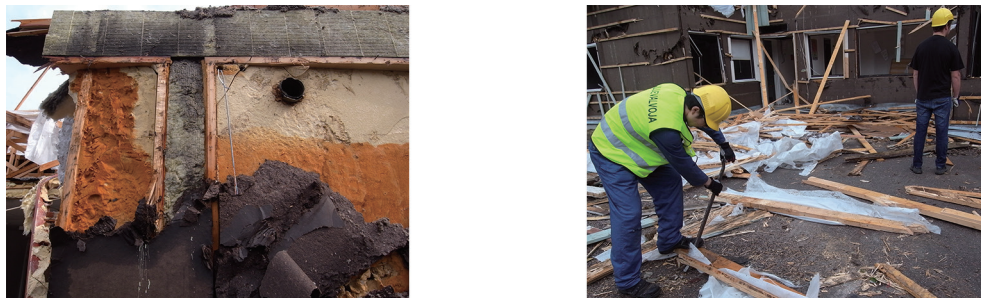
Figure 38a and 38b. View of 2"×3" in element and required effort to remove

Regarding improvements, the 2"×2" and 2"×3" dimensions also have the potential for cascading even though the recovered length became much shorter than the original length and their cross-section is not so large. The most problematic factor for the 2"×2" and 2"×3" is that they were attached to other materials (Figure 38a). This also required more effort to remove all attached materials (Figure 38b).

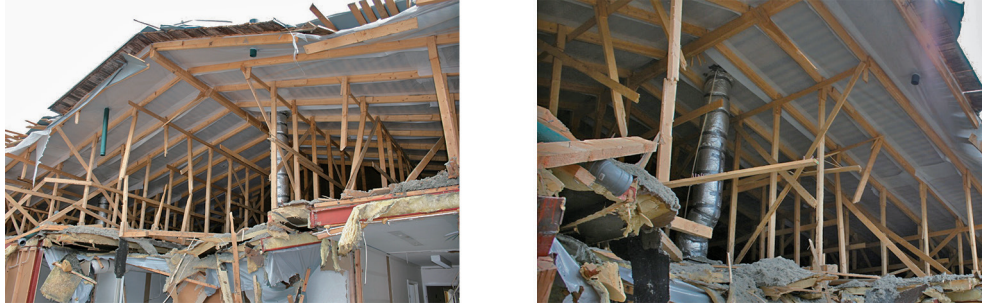
Figure 41. View of 2"×4" and 2"×5" in roof

With respect to the improvements, the original length of the 2"×4" roof pillar varied from 400 to 3000 mm. According to the on site monitoring, the longer the 2"×4" (particularly over 1500 mm) was, the more easily it was broken when it was grabbed and taken out from the roof part by the machine.

Figure 41 shows the condition after grabbing. The broken pillar can be seen in the figure. This breakage was caused by the effect from both the building design and the demolition method. The first problem is in the joint as discussed in the 1"×4" brace. Another problem was in the rough grabbing and pulling by the demolition machine. To avoid the problem, the pillar needs to be more easily detached from the other parts by an improved joint system. In addition, the machine should grab the area near the edge since the longer pillars tended to be broken in the middle part when it was grabbed.

The joint could be designed for easy dismantling using the system discussed in "*Improvement in joint design*". With that system, the demolition could be effective and the condition of the recovered 2"×4" could also be extensively enhanced.

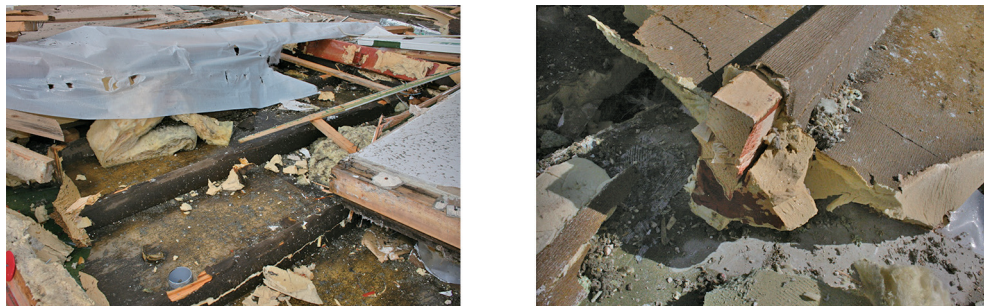
Figure 44. View of 2"×8" in element and the tape attached

Similar to the recovered 2"×2" and 2"×3" wood pieces in the unit part, the problem is attached materials, such as insulation and tape as can be seen in Figure 44. These is also a common problem in the unit part and needs to be considered at the primary design stage by the designers.

About the damage, it was caused when it was grabbed as an element and in separating it from the metal frame. Most of the loss in length was also caused during this process. This demolition should be more “gentle” if the cascading potential is to be enhanced. However, the insulation is still attached to the 2”×8” with tape even if it is recovered in longer lengths, which decrease the potential.

The recovered 2"×8" has the possibility for laminated products. However, it may require more effort to recover the 2"×8" since it needs to be taken out from the element and other materials are still strongly attached. To avoid this extra load, the building design should be reconsidered and a new design such as that discussed in "*Element and modular design for cascading*" should be applied.
